Manhole Inspection Summary

Manhole # S04GG2011MH

Insp Date: **7/29/06 8:54 AM**

Location Address: **3309 BONNIE RD**

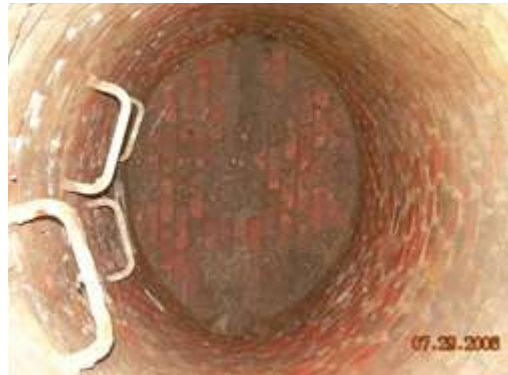
Top View

Adjustment and Corbel infiltration.
Channel debris.

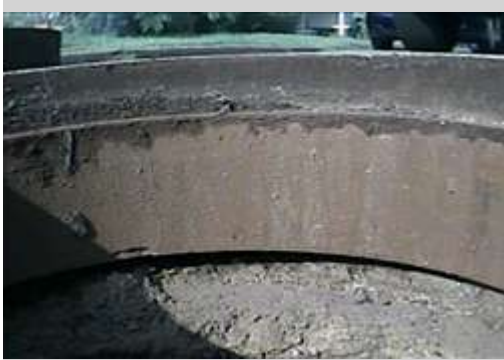
Defect

Frame leaks. Frame offset. Adjustment
deterioration and infiltration.

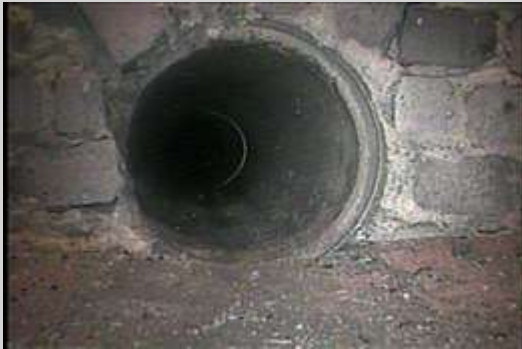
8 in. Circular Gravity Sewer Pipe Out @ 12 O'Clock

Infiltration: **Evidence** Pipe Seal Cond: **Broken**

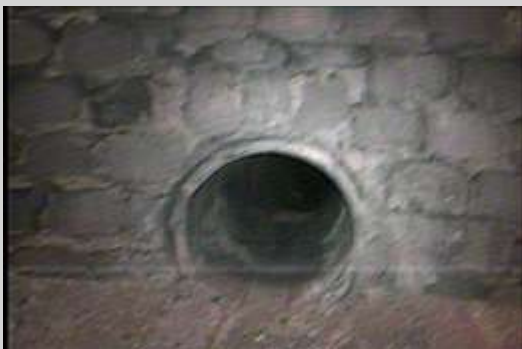
8 in. Circular Gravity Sewer Pipe In @ 6 O'Clock

Deposits: ☐ None ☒ **Mud** ☐ Sludge ☐ Debris ☒ **Grease**

Silt Depth: **0** (in.) Deposits Extent: **Light**

Infiltration: **Evidence** Pipe Seal Cond: **Unknown**
